Manhole Inspection Summary

Manhole # S33K1_014MH

Insp Date: **3/25/08 11:23 AM**

Location Address: **2838 Potte St.**

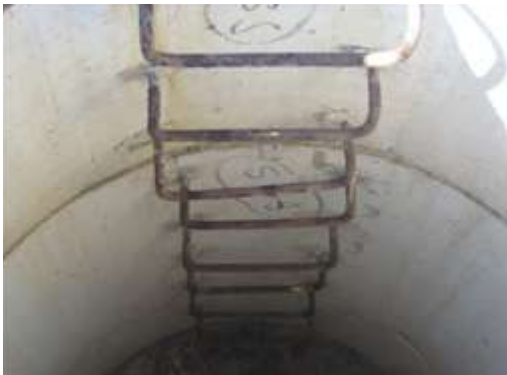
Steps Count: **8** Missing: **0** ☒ Corroded

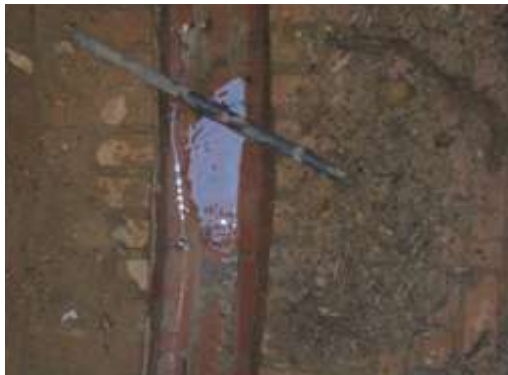
Defect 1

Foreign Objects

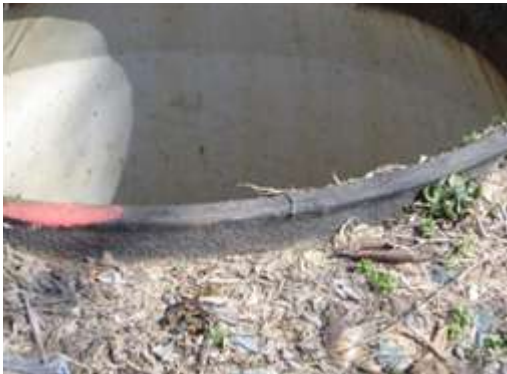
Defect 2

Frame Above Ground

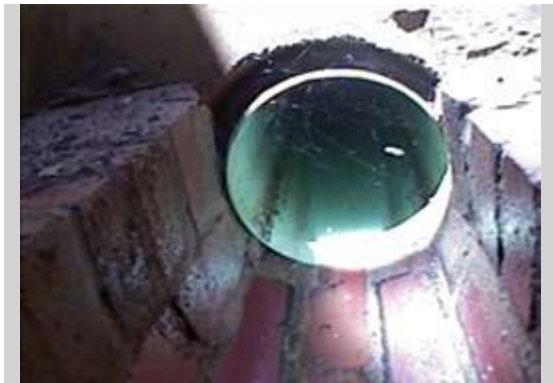
8 in. Circular Gravity Sewer
Pipe In @ 7 O'Clock

Pipe Height: **9.6** (in.) Rod and Bar (Angled)
Pipe Material: **PVC** ☐ Pipe Lined
Invert Depth: **10.20** (ft.) Flow Characteristics: **Slow**
Deposits: ☒ None ☐ Mud ☐ Sludge ☐ Debris ☐ Grease
Silt Depth: (in.) Deposits Extent:
Infiltration: **None** Pipe Seal Cond: **Sound**
